85 SX Engine Mounting Bracket Tension / Rear Shock Eye Width

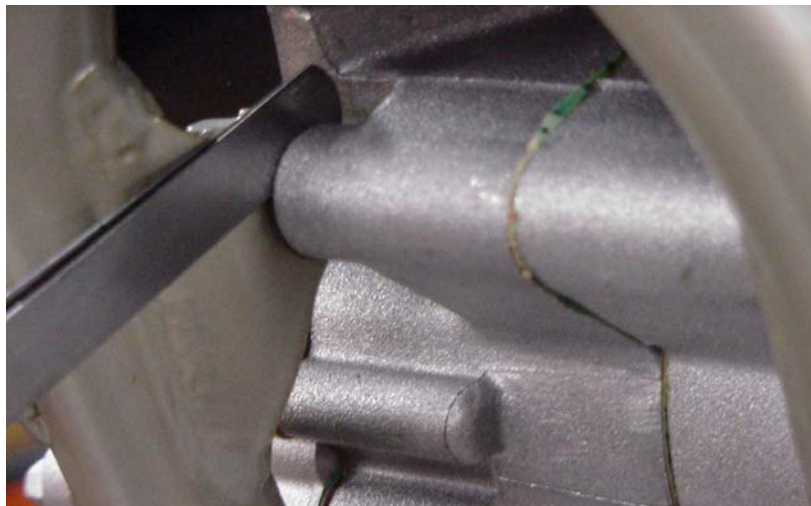
- » **Due to manufacturing tolerances and welding deformation** in the frame production process, engine mounting brackets may have been welded with too much width between them. This deviation could cause stress on the bracket welds when the front engine mounting bolt is installed and consequently cause tears.

- » **To check the pre-tension**, first, you must make sure that the swingarm nut is torqued to 100NM, then loosen and remove the front engine-mounting bolt and check the clearance between the engine cases and the mounting brackets on both left and right sides using a feeler gauge. According to the determined measurement, install the appropriate compensation washers and tighten the engine mounting bolt to 40NM. Compensation washers should be the thickness of the feeler gauge used to determine the clearance. Example: if the maximum clearance was determined to be 1.0mm using the feeler gauge, then a 1.0mm washer should be placed between the engine case and the mounting bracket to compensate for that clearance. No compensation washers will be needed for clearances less than 0.5mm. Compensation washers with a width of 0.5mm (**p.n. 0988101605**) and 1.0mm (**p.n. 50232030050**) can be ordered through the KTM Parts Distribution Center.

- » **It is imperative that the pre-tension** between the engine cases and the engine-mounting brackets be checked on all 85 SX motorcycles you currently have in stock before delivering the motorcycle to the customer.

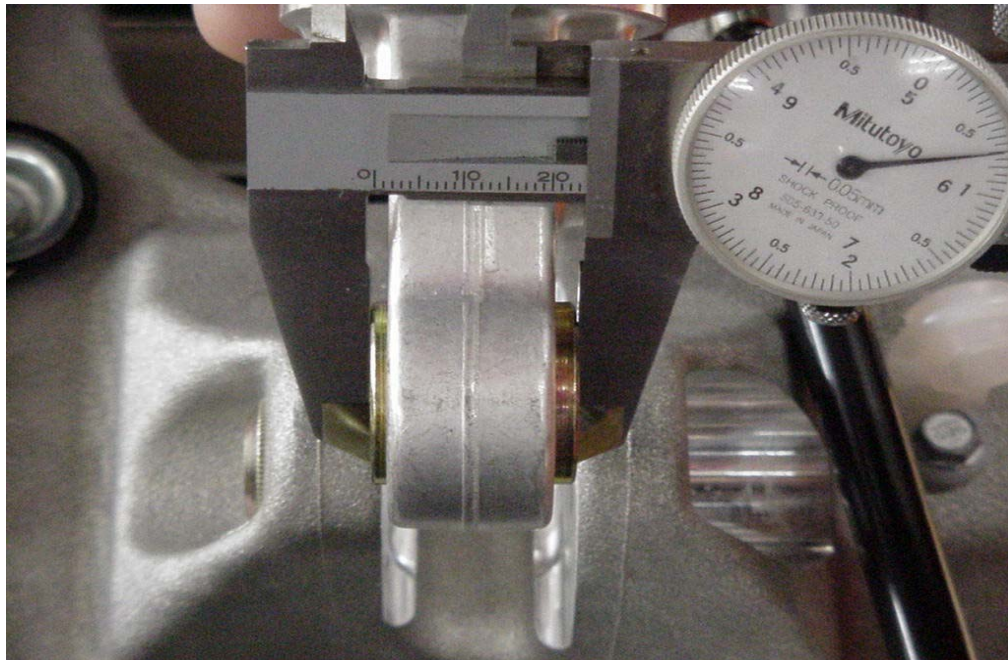
- » **In conjunction with carrying out the Engine Mounting Bracket Inspection**, you also need to measure the width of the lower rear shock eye. It must not measure less than **23.80mm**. If this measurement is less; you should replace both adaptor bushings (**p.n. 46180007**), which can also be ordered through the KTM Parts Distribution Center.
